Accommodation of Disabled Visitors at Historic Sites in the National Park System

by
**Duncan S. Ballantyne
Harold Russell Associates, Inc.
Waltham, Massachusetts**

**Park Historic Architecture Division
Cultural Resources Management
National Park Service
U.S. Department of the Interior
Washington, D.C.
1983**

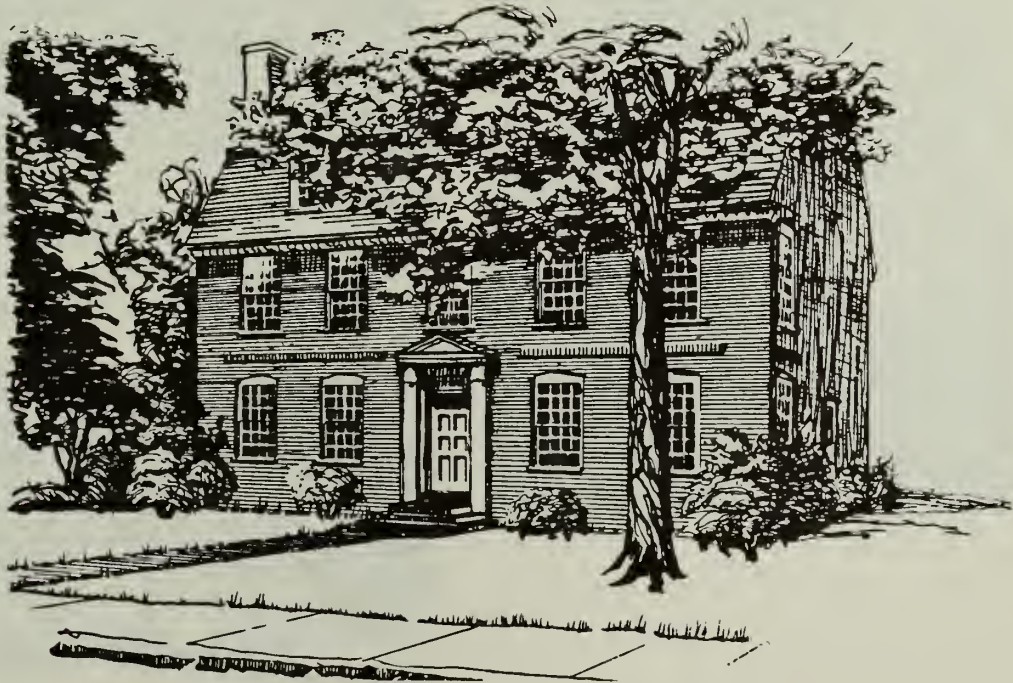
Entry to the Derby House

The Derby House, at Salem Maritime NHS, erected in 1761, presents a typical entrance to a private house. Note the four front steps and the absence of railings.

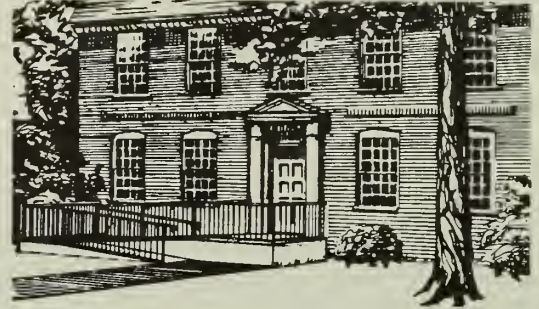
Portable or fixed ramp.

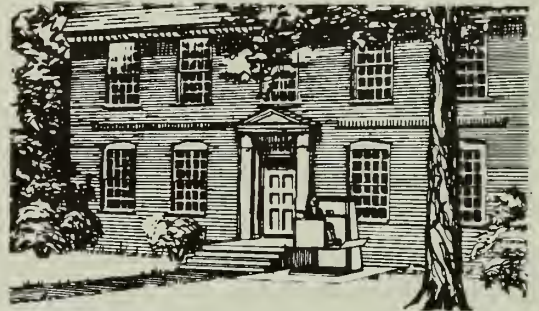
Vertical or inclined lift.

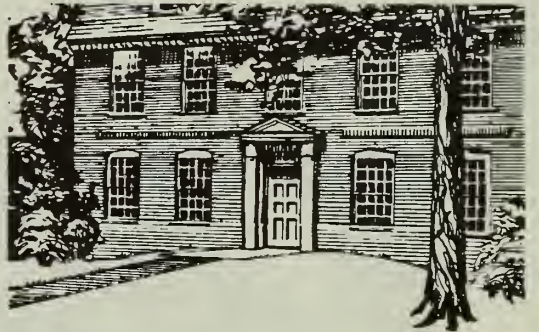
Regrade area around entrance.

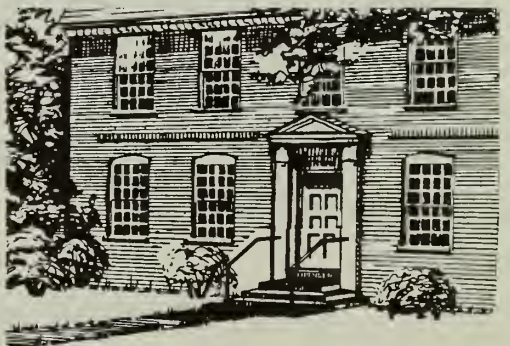
The lack of railings or their design can present safety problems for most persons with mobility and visual impairments.

Install handrails.

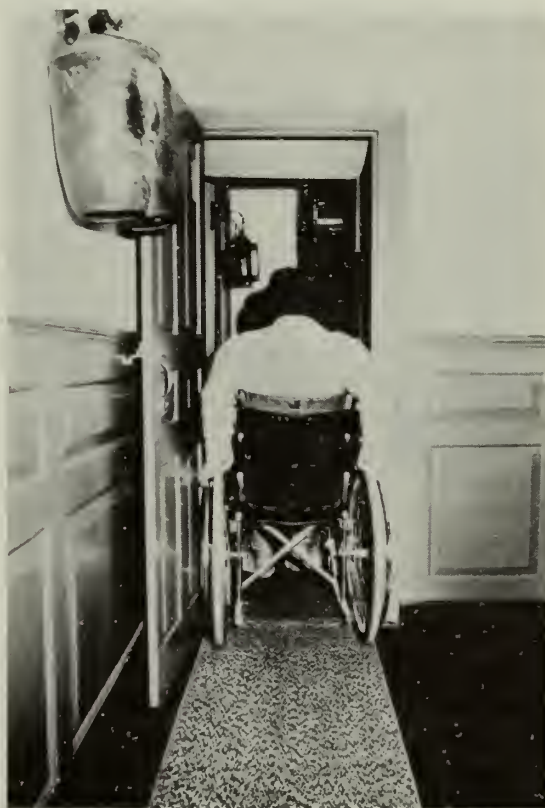
Access to the entire first floor of the Derby House can be accomplished by rerouting disabled visitors through other doorways which are wider and connect all rooms. The rooms are usually roped off, but exceptions can be made for disabled people.

The Derby House has both a narrow hallway and doorway, typical features of an 18th-century colonial residence.

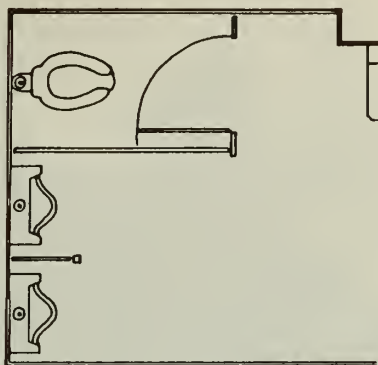
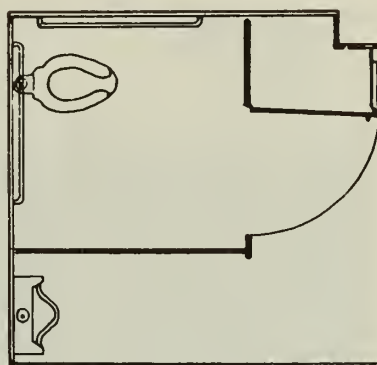
These before and after sketches show how two standard stalls can be made into one large stall which is wheelchair accessible.

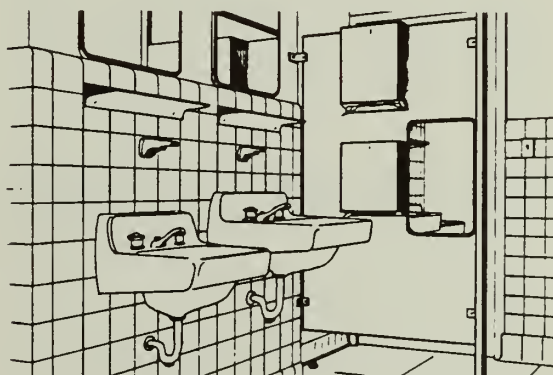
An accessible toilet room. Note the lowered sink, towel dispenser and mirror.

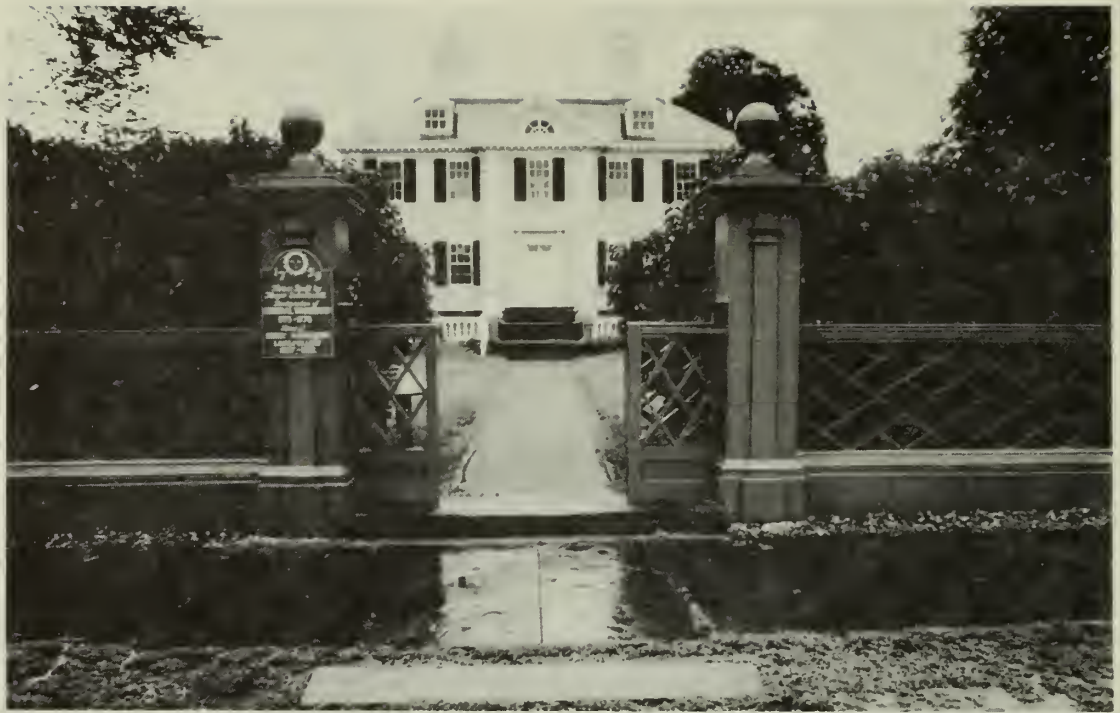
Access to the Longfellow House is best accomplished using a driveway and small parking area located to the left of the house. Spaces in the parking area could be reserved for disabled individuals.

The House at Longfellow NHS in Cambridge, Massachusetts seems inaccessible from the street. Note the curb, long brick walk and steps up to a terrace at this Georgian mansion.

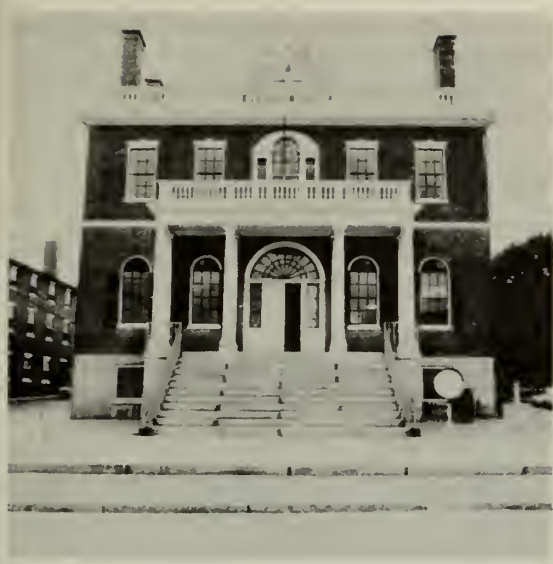
The Custom House presents a particular accommodation challenge because of its inaccessibility to those in wheelchairs and difficult access for those with mobility limitations. The twelve granite steps at the only visitor entrance make ramps unfeasible, and alternate side entrances have narrow, steep stairways. Because the Bonded Warehouse building is adjacent to the rear of the Custom House, no access to the Custom House is provided at the rear.

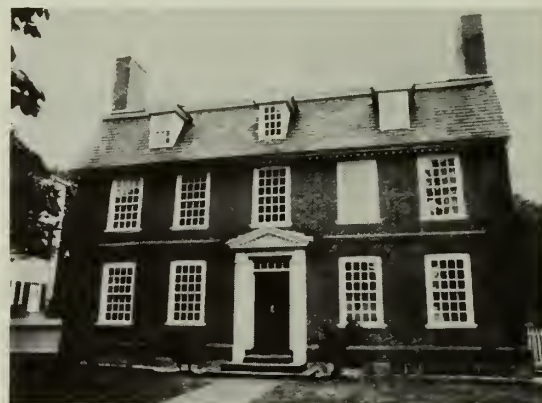
III. ACCOMMODATION PROBLEM IDENTIFIED A survey of the site using the Survey Checklist revealed the following problem related to access to the main floor:

—the narrow (23½ inches) doorway in the center hallway is a barrier to passage by visitors in wheelchairs.

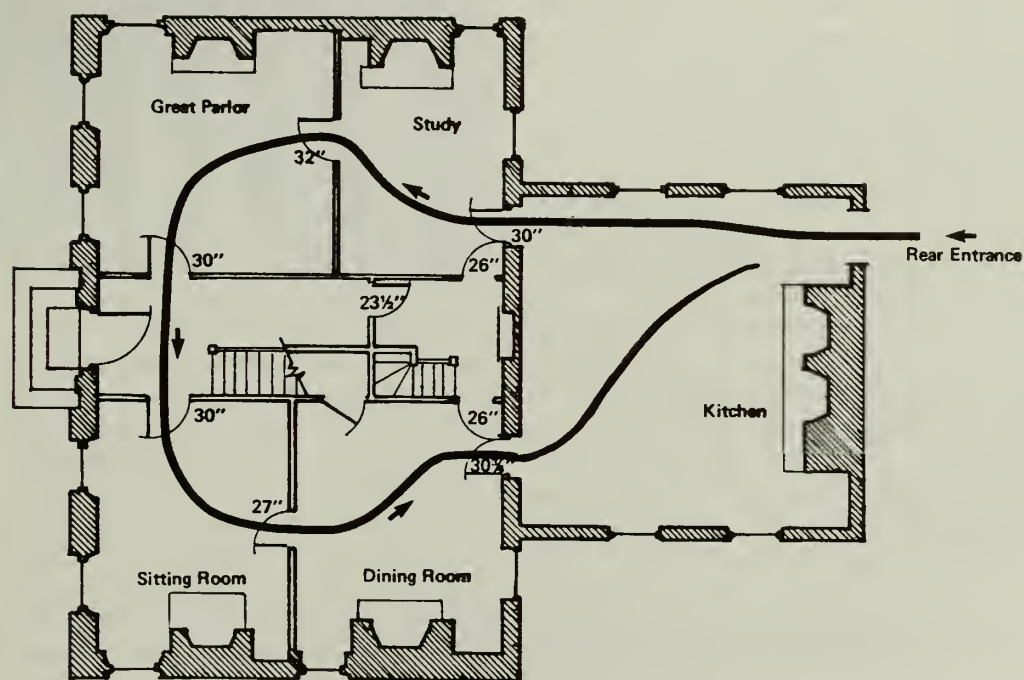
As noted below in the sketch of the first floor, the second solution calls for the tour to go from the kitchen through a 30-inch doorway (normally kept closed) to the study. Visitors in wheelchairs would then be permitted to travel the length of the study, pass through a 32-inch doorway and enter the great parlor. Thirty-inch doorways at the hallway would allow wheelchairs to pass through into the sitting room. From there, a 27-inch doorway might prove inaccessible to some individuals in wide wheelchairs. Those in standard wheelchairs would have to be pushed through the opening, so as not to hurt their knuckles while propelling themselves through the narrow opening. Travel through the dining room and back to the kitchen would complete the tour. Those visitors who found the 27-inch doorway to be a barrier would have to retrace their route in order to return to the kitchen.

Sketch of first floor Derby House showing alternate visitor flow.

When presented with the above two solutions to the narrow center doorway problem, the second option is clearly superior. It achieves access by changing the tour route and has negligible effect on the historic fabric when individuals in wheelchairs, and possibly accompanying visitors, travel over the well-worn floor boards. The second option would necessitate changing the tour and accompanying interpretation but it is felt that if all visitors in the group were given this modified tour, no segregation or separate treatment of a disabled person

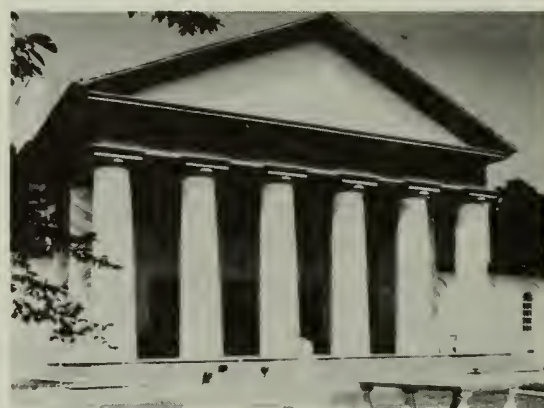
- III. A survey of the site using the Detailed Survey Checklist revealed the following two problems related to parking lots and walks:

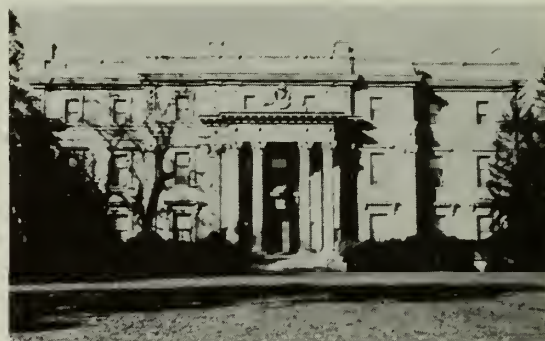
A survey of the site using the Detailed Survey Checklist revealed the following problem related to access to other floors:

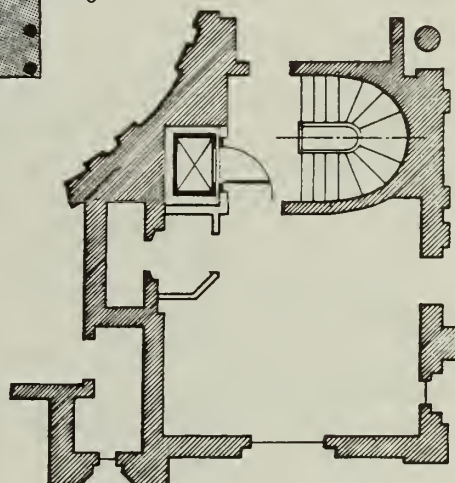
Servants Stair & Elevator

Enlarged view of servants stair and elevator
